# Forensic Investigation of Courthouse Square

555 Court Street NE  
Salem, Oregon

May 2, 2011

Project No. 103-93451.100

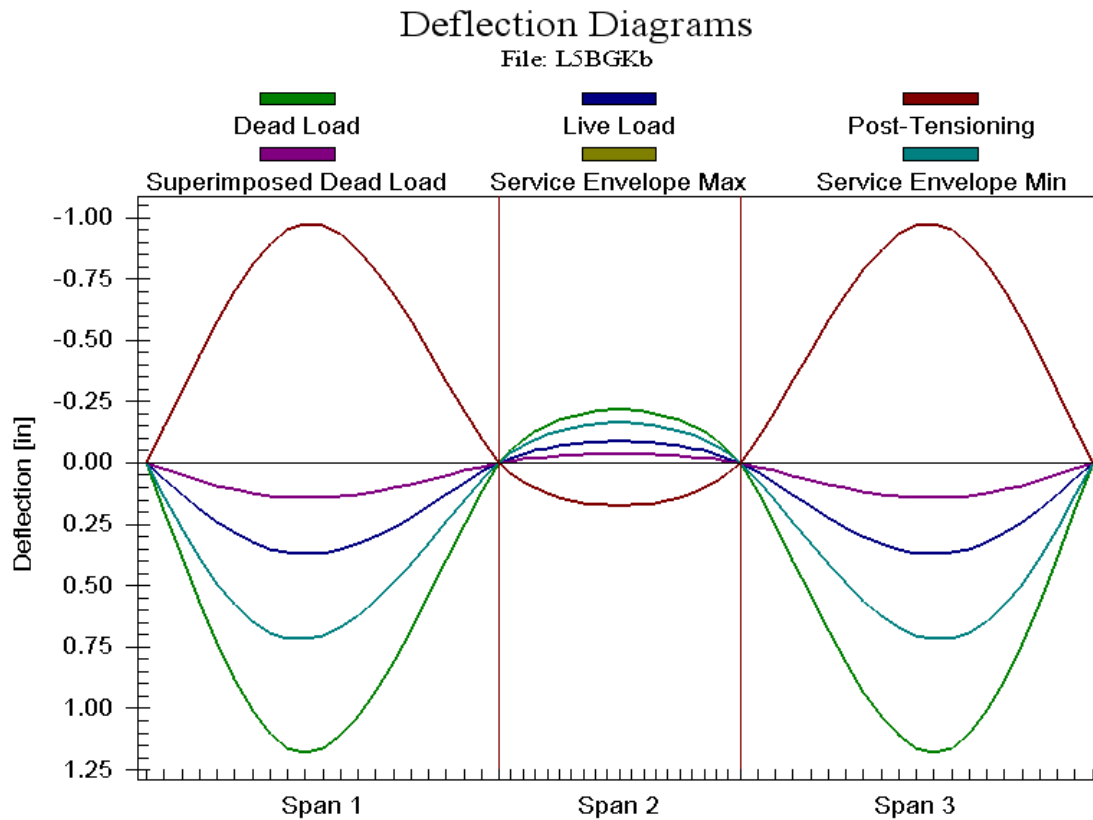
**Figure 1 – Office - Grid K with full live loads**

These differences in balanced loads account for deflected slab shape as measured in previous investigations. The office slabs are deflecting downward in long spans of the transverse direction while the significant overbalancing in the longitudinal direction causes crowning mid-grid rather than deflection.

Figure 1 below shows a typical deflection pattern for the transverse (north-south) direction. The exaggerated effects of the two end spans can be clearly seen by reviewing the Service Envelope Min pattern. Figure 2 shows the crowning experienced by the slabs in the longitudinal (east-west) direction due to post-tensioning forces.

Deflection Diagrams Figures show short term deflections only (long term deflections are assumed by the program to be twice the amount shown in these diagrams) and are separated into individual effects (dead, live, post-tensioning, etc.). To understand the deflected shape of the slab immediately after stressing, it is necessary to add the post-tensioning, dead and superimposed dead load effects. The combination of these is shown by the Service Envelope Minimum line.

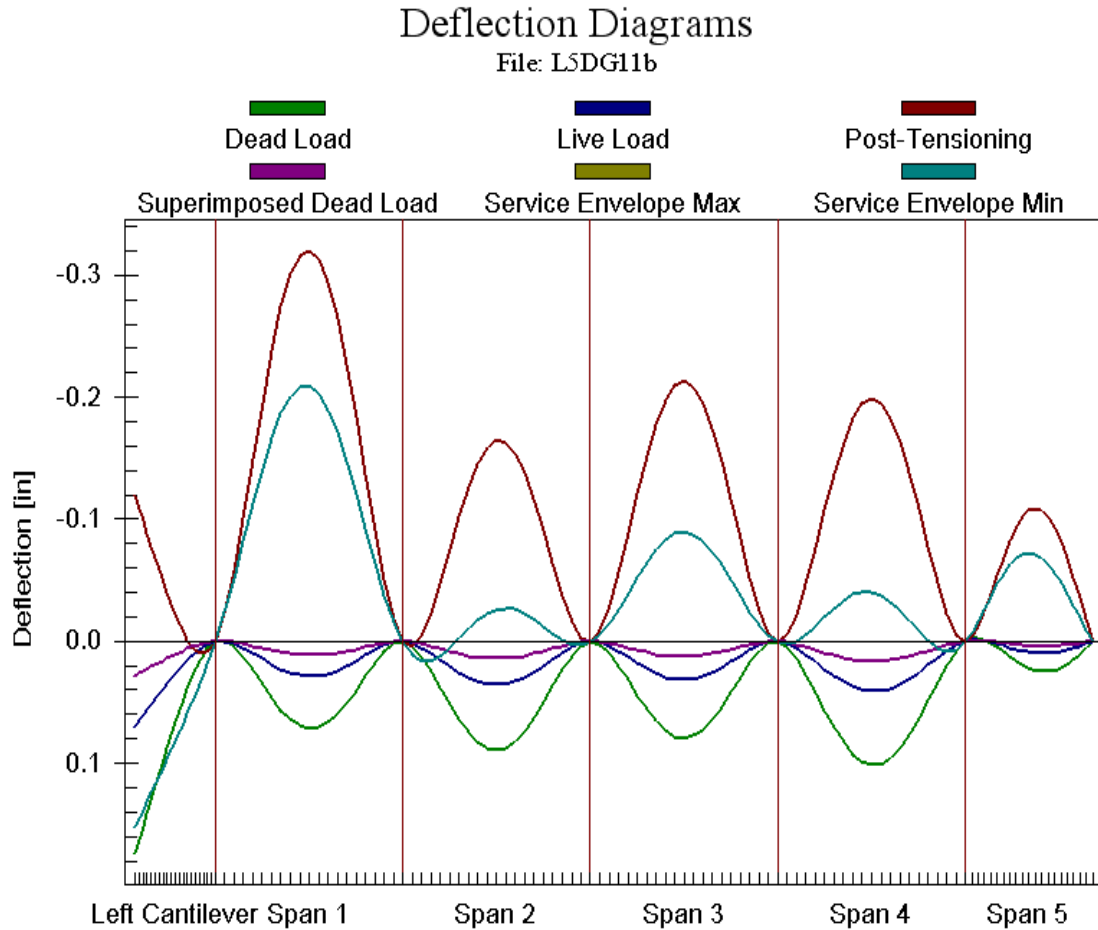
**Figure 2 – Office - Grid 11 with full live loads**

This ADAPT analysis, however, does not account fully for the measured movement in the slabs. Deflections calculated by the program vary between 1.25" in the transverse direction and -0.7" in the longitudinal direction, including the long term deflection increase of 100%. This is roughly half the measured deflections in the office building which, depending on the datum selected, are often as high as -1.5" in the longitudinal direction and 2.5" in the transverse direction.

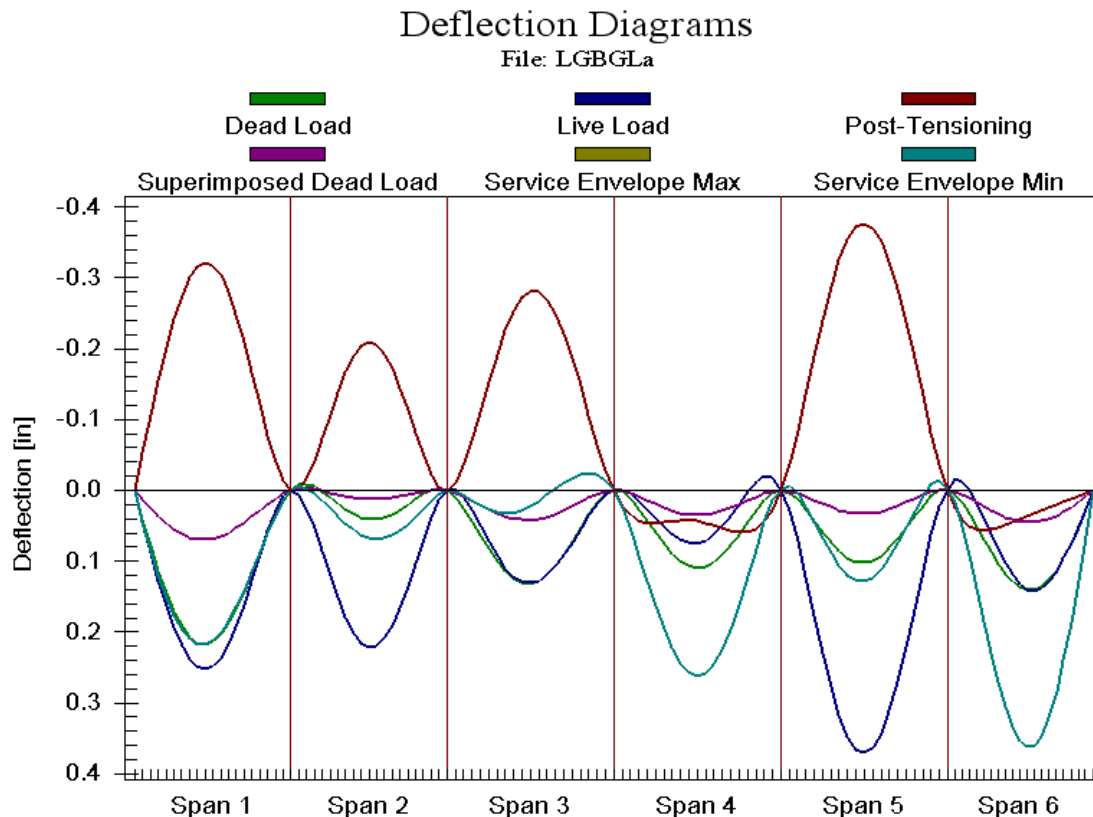
**Figure 3 – Bus Mall - Grid L with reduced live loads**

In the Bus Mall, compressive stresses due to post-tensioning vary between 315 psi and 424 psi. Due to heavy topping and high transit loading, however, even these high stress levels do not balance dead loads and would require significantly more mild reinforcement than provided to resist tensile stresses. Analysis indicates that, in some places, an additional 250% of bottom reinforcement would be required and an additional 500% of top reinforcement.

Figure 3 shows the initial deflections due to various loads for grid L at the Bus Mall Level. (Please see the discussion regarding interpretation of these diagrams under Office Building Slabs section above.) At the Bus Mall level, deflections generally are not an issue. Of more concern are the tensile stress levels, both top and bottom, and the shortening of the slab due to both elastic shortening and creep.

For post-tensioned slabs this large it is customary and desirable to provide slip joints to reduce cracking due to compression shortening and creep. A detail for a slip joint between walls and the slab was provided. The location of these joints appeared to be in the corners of the slab edge with the exception of the north wall, where no slip joints could be located using the drawings. While this pattern of joints may be adequate for slabs with moderate compressive stress, it does not appear sufficient to
